OPERATIONAL PROBLEMS OF THE AIR TRAFFIC  
CONTROL RADAR BEACON SYSTEM. 1972  
SEMINAR HELD AT THE SHELburnE HOTEL,  
ATLANTIC CITY, NEW JERSEY, ON FEBRUARY 8  
THROUGH 11, 1972

National Aviation Facilities Experimental Center  
Atlantic City, New Jersey

April 1973

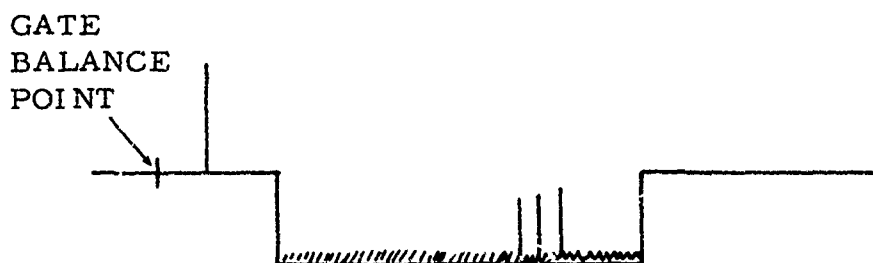
#### TP3, AND 10, NORMAL WAVE SHAPE (NEGATIVE)

When tube starts to deteriorate, the gate will begin to approach the baseline and then go positive. When this gate has gone positive, slight adjustments are usually made to the delayed video threshold to compensate for weak video. When sensitivity and interference become a problem and check at TP-3 and 10 has gone positive, tube should be replaced.

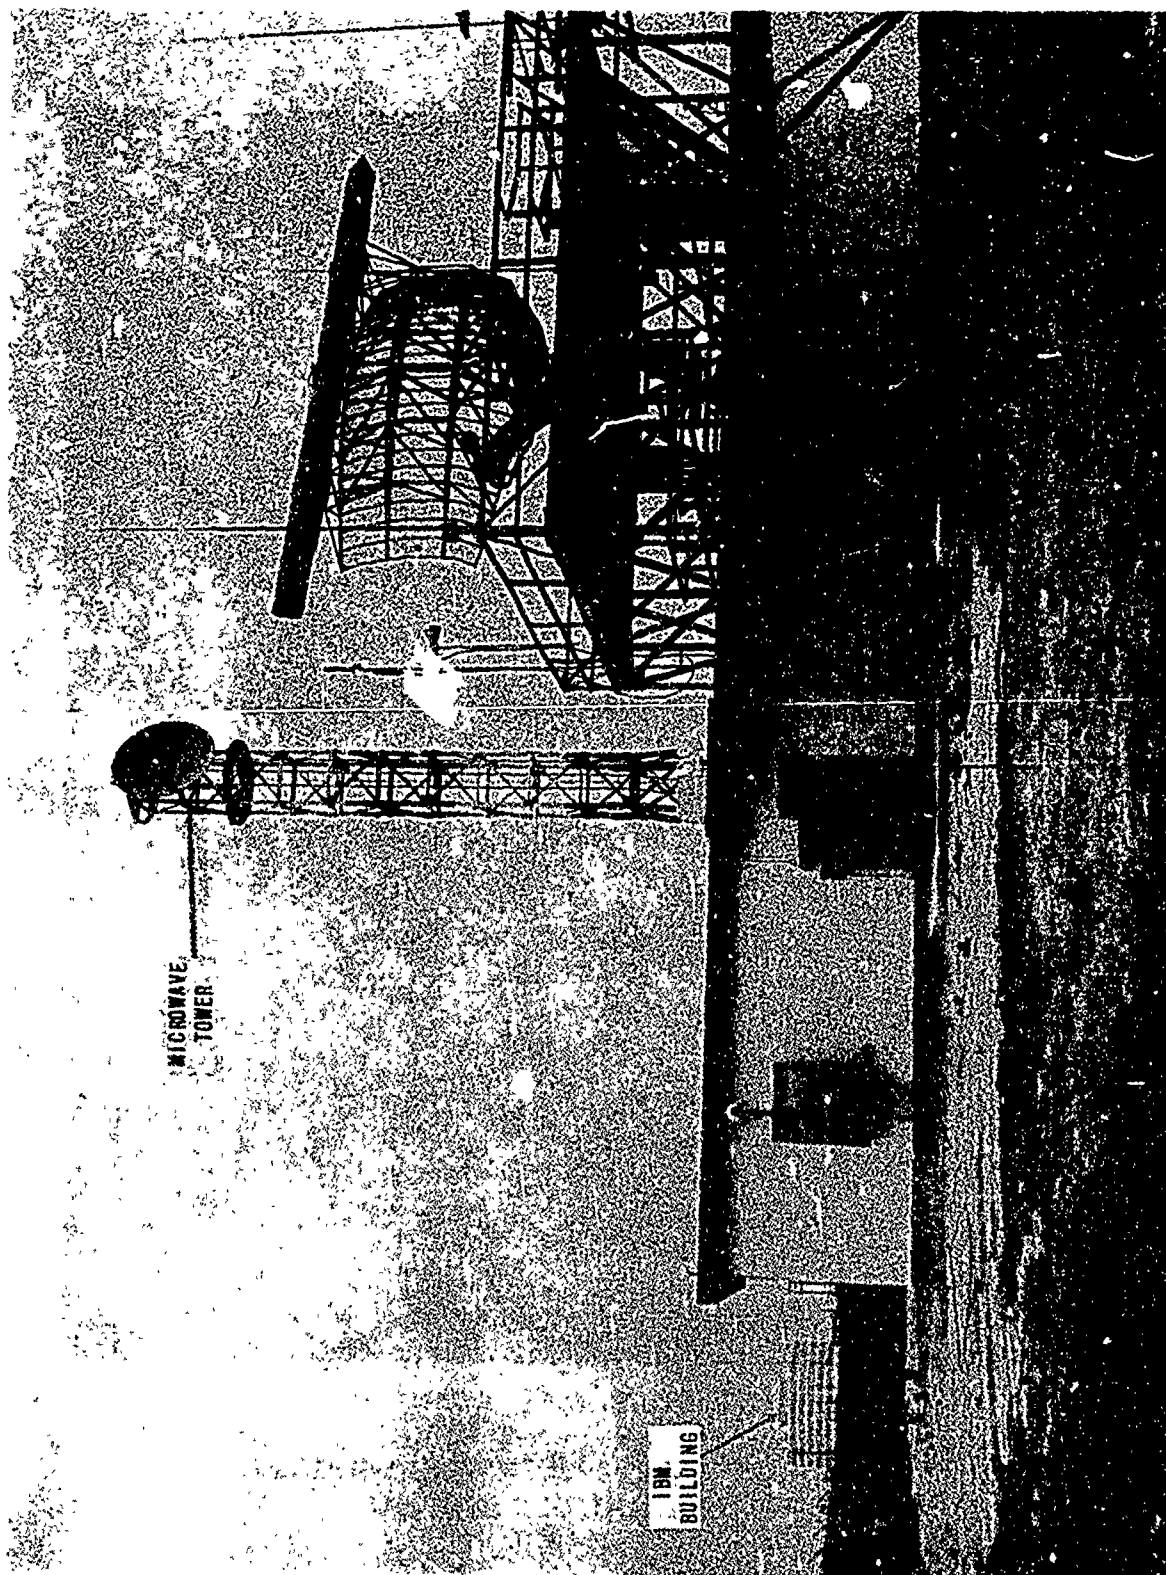
FIGURE 41. LOS ANGELES ASR-4 RADAR BEACON INSTALLATION

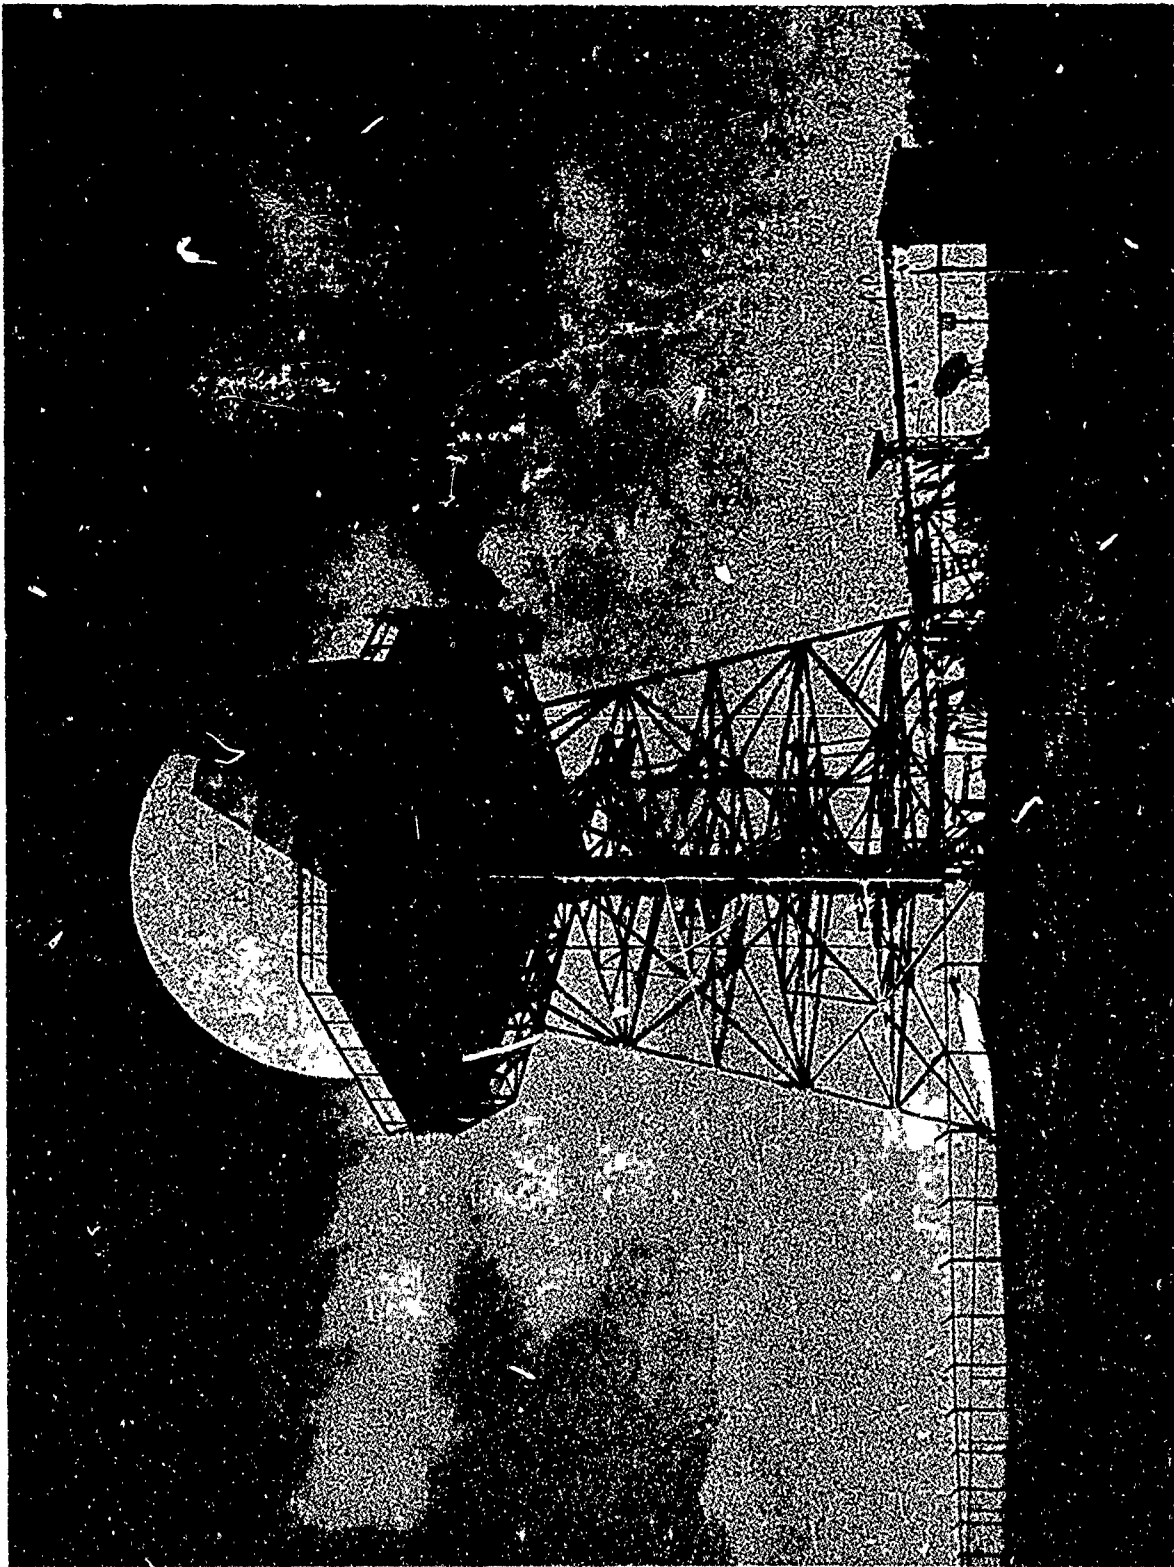
FIGURE 49. THE TREVOSE ANTENNA

In December of 1970, a request was made by the Eastern Region for NAFEC participation in the investigation of the Trevose, Penna., reflected radar beacon reply problem. Reflected radar beacon replies were reported to have appeared in the Salisbury, Maryland, area when aircraft were flying in the vicinity of J. F. K. International Airport on Airway J-42, and when aircraft were flying on Airway J-80 west of the Trevose Site (Figure 48). Some reflected radar beacon replies were also reported to have appeared northeast of the Trevose Site when aircraft were flying on Airway J-80 west of Trevose. The problem of reflected replies existed since the site was installed and was one of the main factors that prevented commissioning of the facility. (Figure 49)
